SNOWPLOWS

SERVICE BULLETIN NO. 26

81018, 81023 and 17120 Mountings

2001 & Later Chevrolet C/K 2500/3500

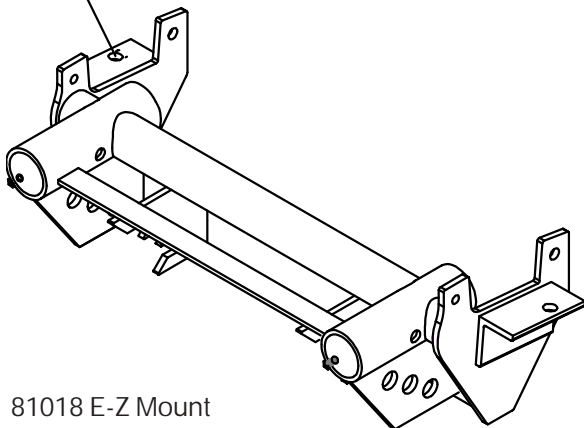
81018 E-Z Mount
Part No. 80339 Clevis

General Motors has made a frame change late in 2001 affecting our mounting installations on 2001 & Later 2500 and 3500 C/K trucks. GM has relocated a hole on the bottom side of the frame for the passenger side Tow Hook.

Hole will need to be slotted 1/4" to the rear of vehicle
