# NOTICE

## Blizzard Power Plow - Model 810

Issued December 3, 1999

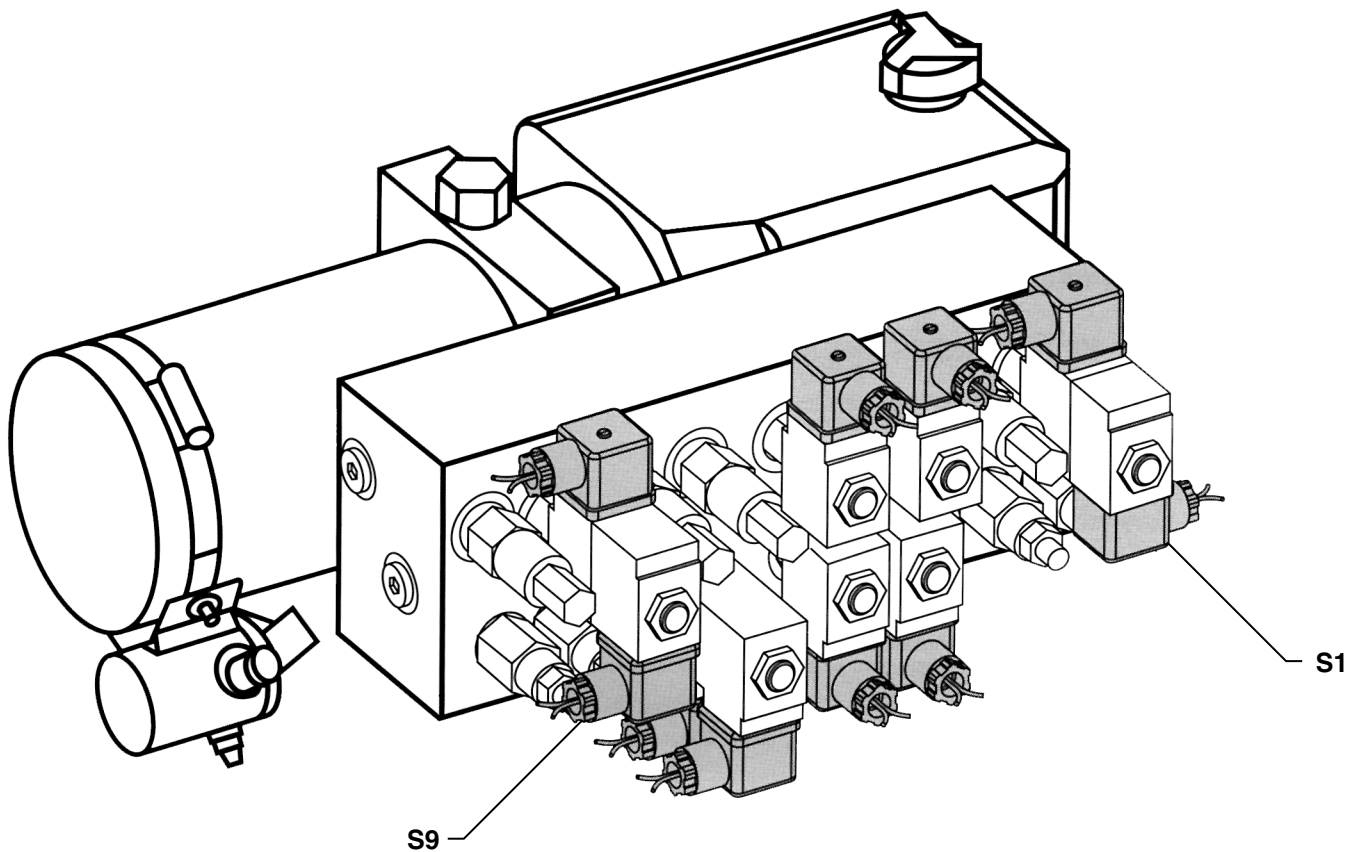
The manifold assembly has ten DIN connectors that attach to each of the red DIN solenoids. Depending on the model vehicle you are installing your Power Plow on, the DIN connectors can interfere with the bumper of the vehicle. When the snowplow is in the raised position, the two top solenoids ("S9" and "S1" indicated in the stamping on the block) make contact with the bumper. This action, or the forceful impact of the plow into a snow bank in the raised position can damage a solenoid. Take corrective measures by installing **ALL** DIN connectors as illustrated below or increase the tension on the torsion bar on the vehicle and lower the push beam height (recommended push beam height is 12-1/2").

Notice the two DIN connectors and respective solenoids have been rotated such that they face down and outward. Also, if the DIN connectors are positioned wrong, they can interfere with the pump and manifold cover.
