Reskin a Rusty Meyer Blade

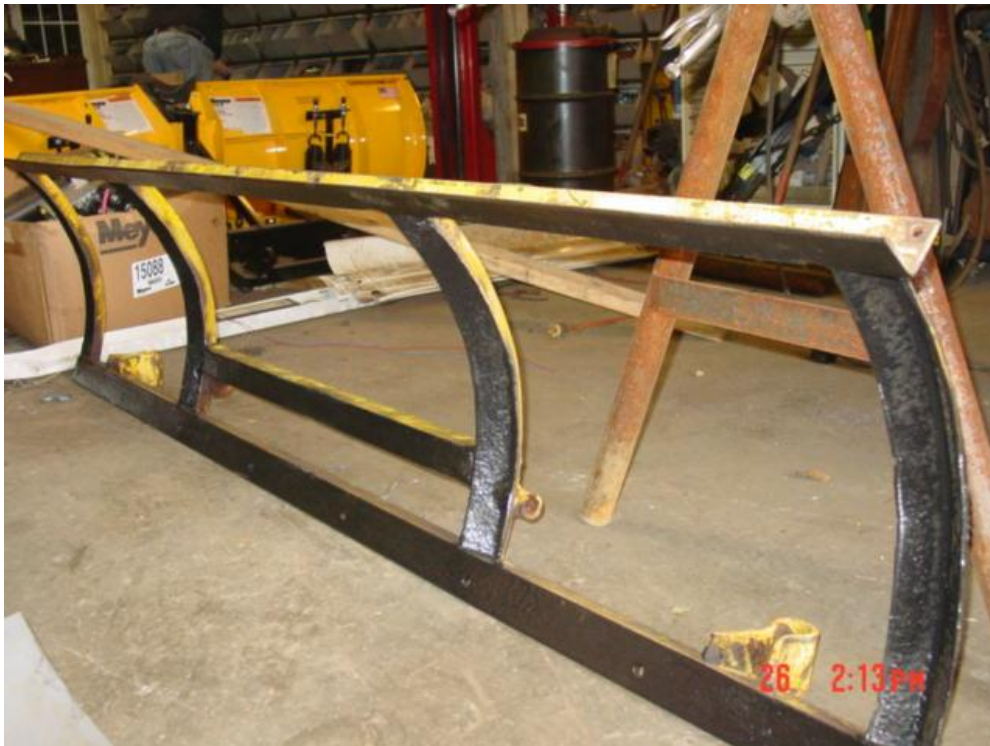
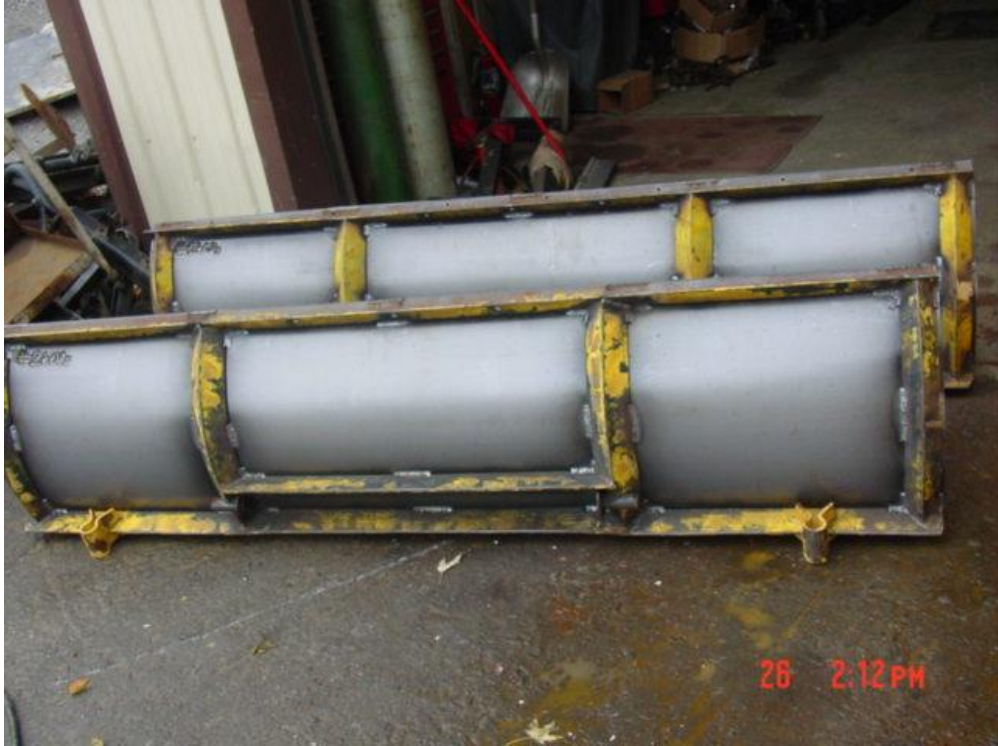
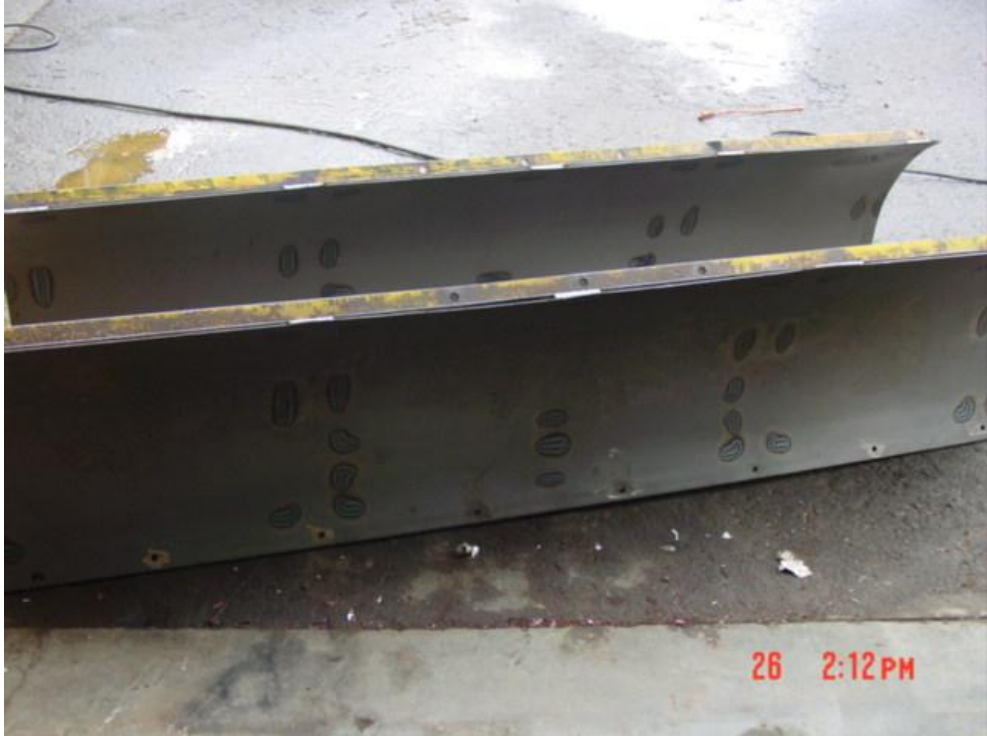
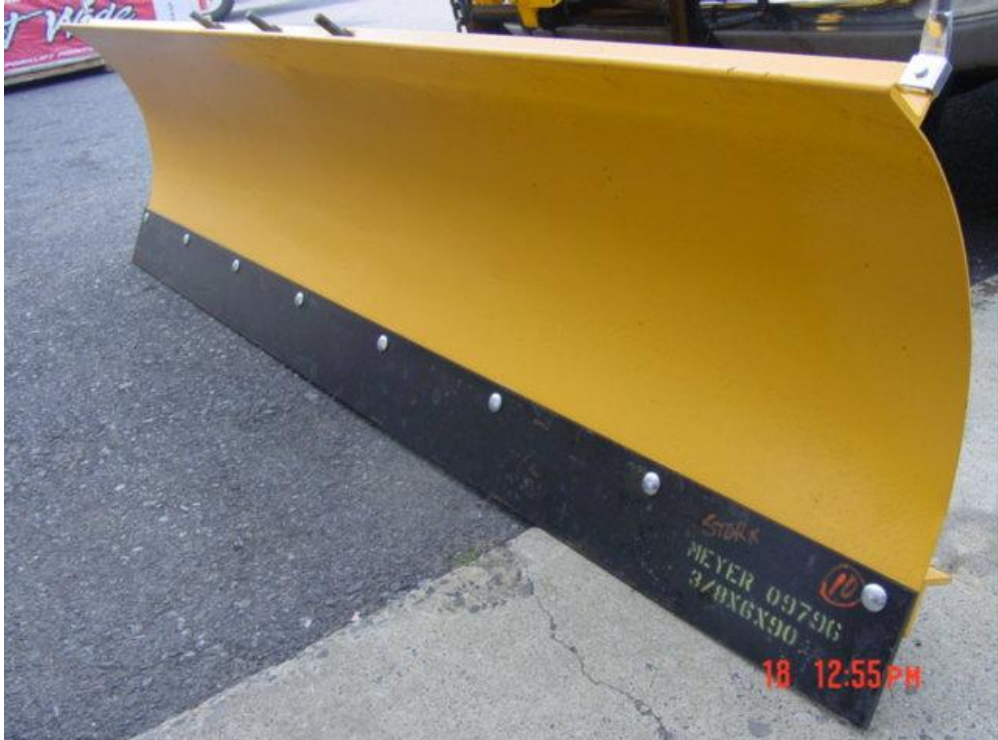
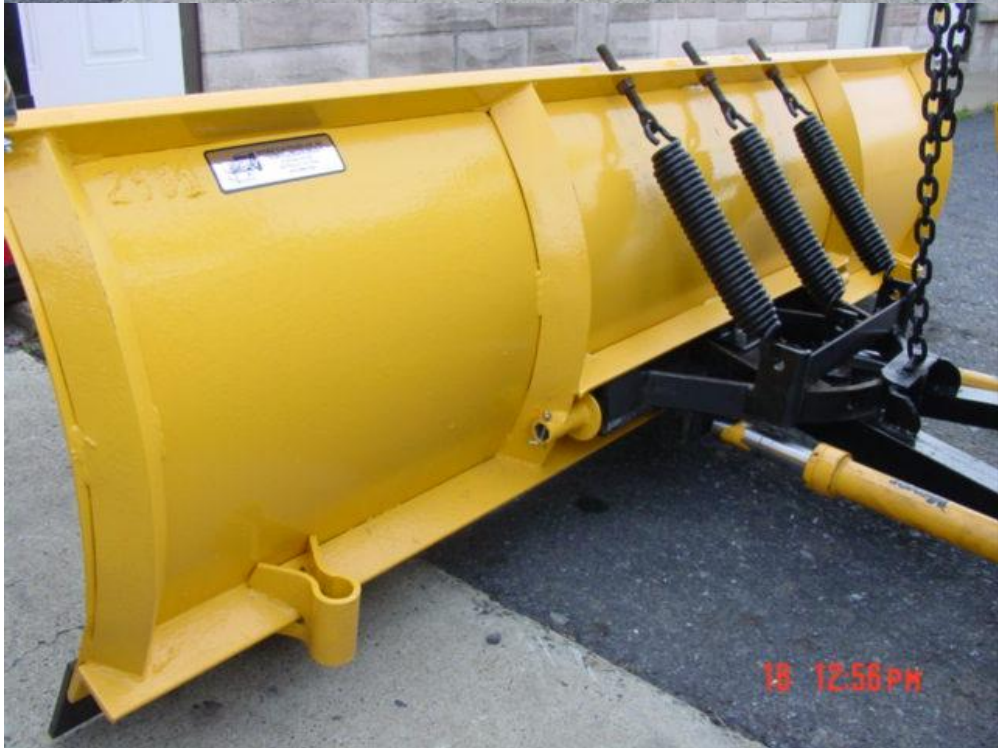
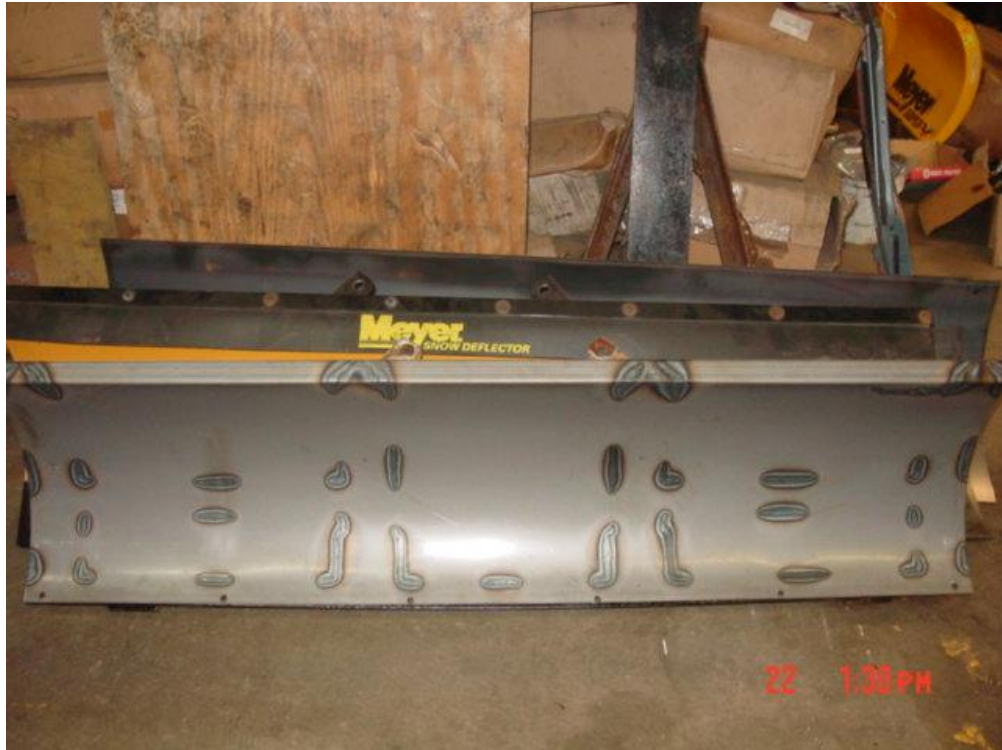
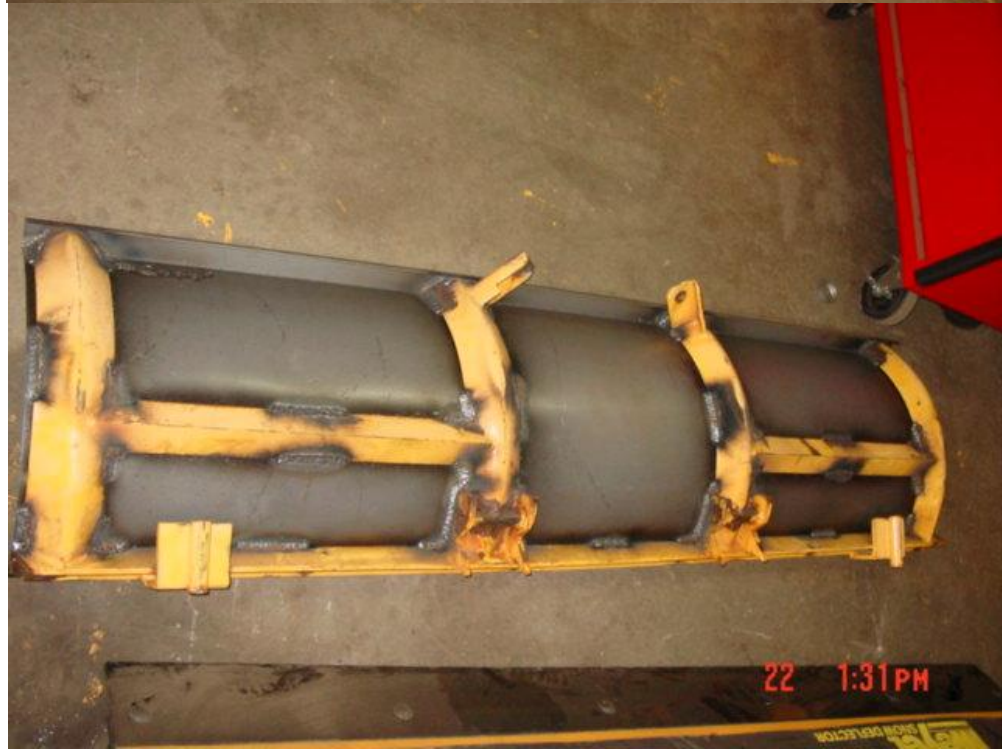
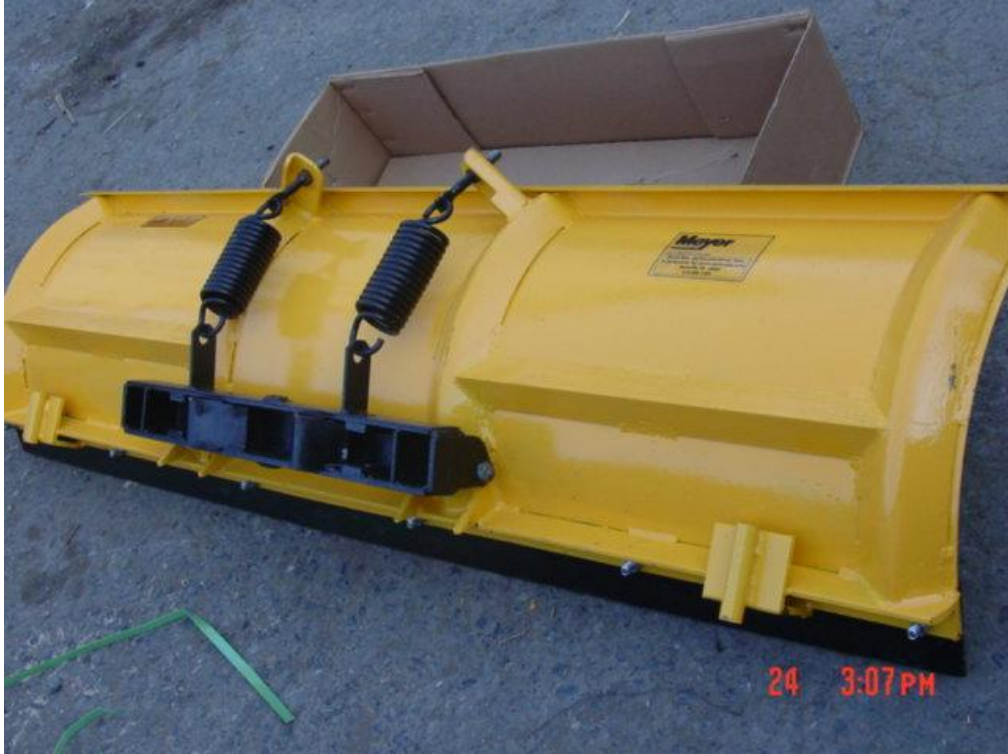
Below are some pictures of the process:

What we do is: (1) cut the skin then grind all scale out of the frame, (2) paint the inside of the frame along with the covered areas of the skin to prevent the bare metal from rusting, (3) clamp the skin to the blade to get a straight tight fit, (4) weld them together, (5) drill out the holes to bolt-up the cutting edge and, finally, (6) we paint them with a few coats of Meyer SnoFlo paint.
